Transportation Safety Board
of Canada

TRANSPORTATION SAFETY

Issue 28 – March 2005

A I R

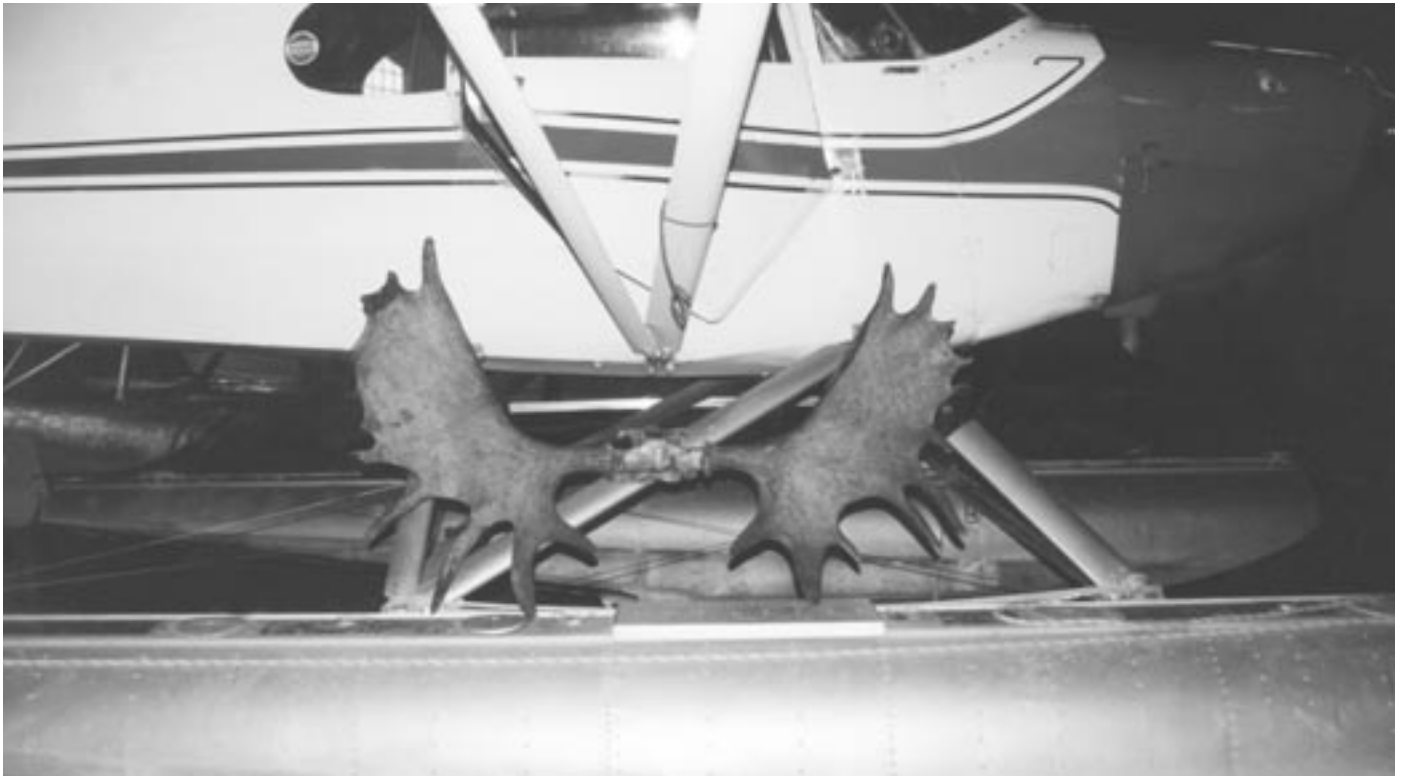
One set of moose antlers was found secured to the right float diagonal strut and entrance step. The antlers spanned 53 inches from tip to tip. They had been tied parallel to the longitudinal axis of the aircraft, above the float deck, with the palms and tips up.

External loads create parasite drag, which degrades aircraft performance. Animal antlers are not streamlined and may create unusually high drag, considering their size. Several experienced Piper PA-18 pilots were asked about the performance degradation associated with carrying antlers externally.

Set of moose antlers secured to the right float

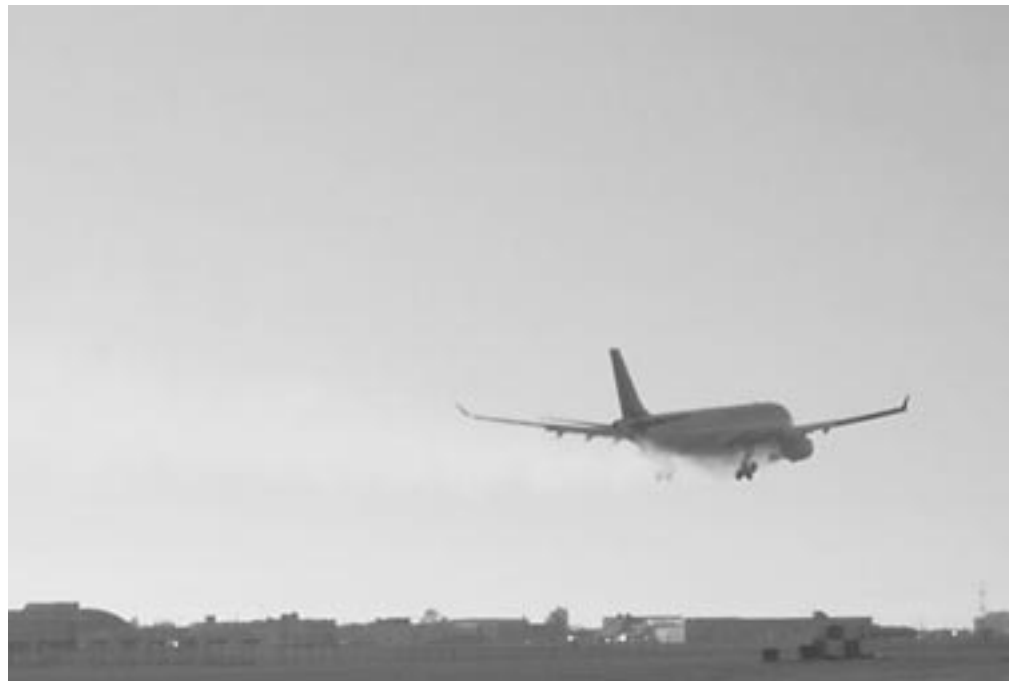
to be approximately 20 000 kg per hour, yet the engine continued to run normally. These increases and, perhaps, engine vibration caused the LP fuel line to detach from the fuel/oil heat exchanger because the retainer was missing, resulting in a large vapour trail.

Vapour trail behind the aircraft

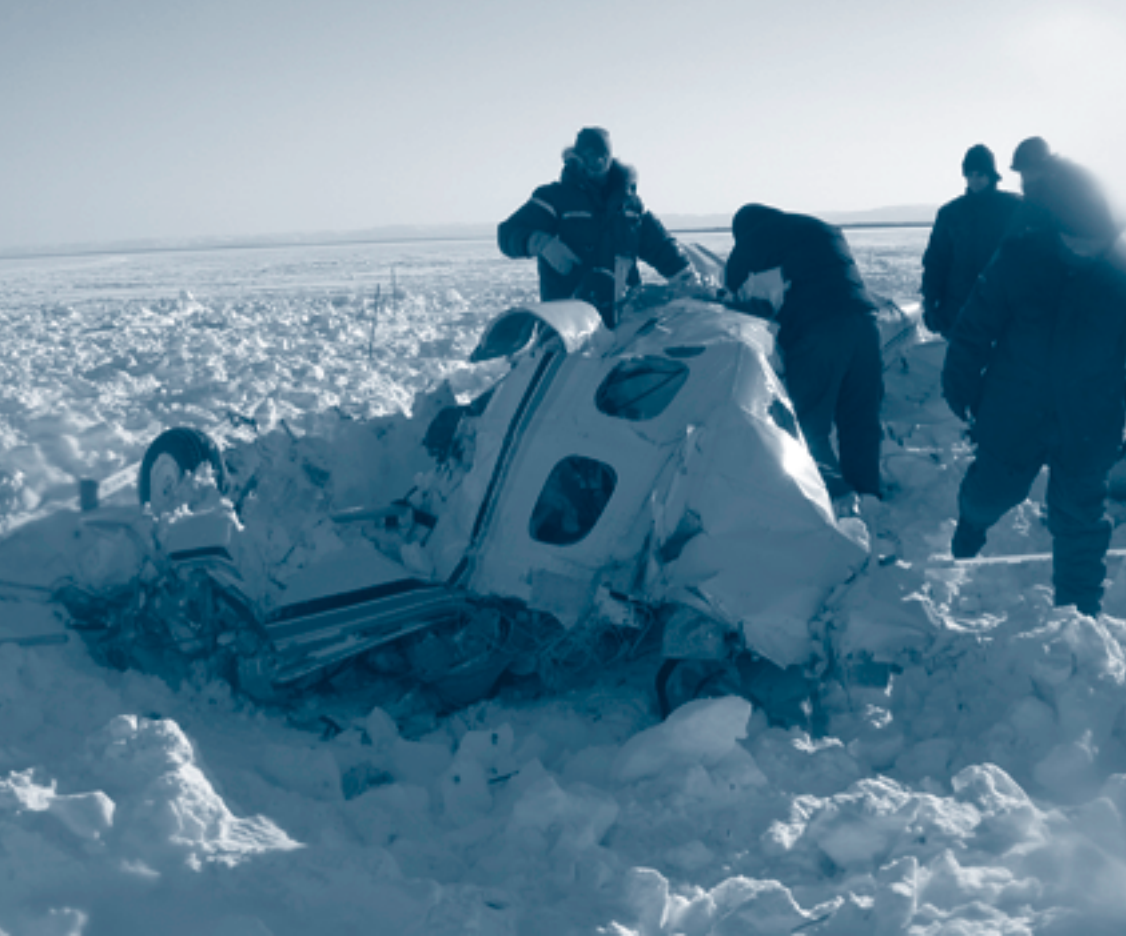
The aircraft struck the ice-covered surface of Hamilton Inlet, Newfoundland and Labrador.

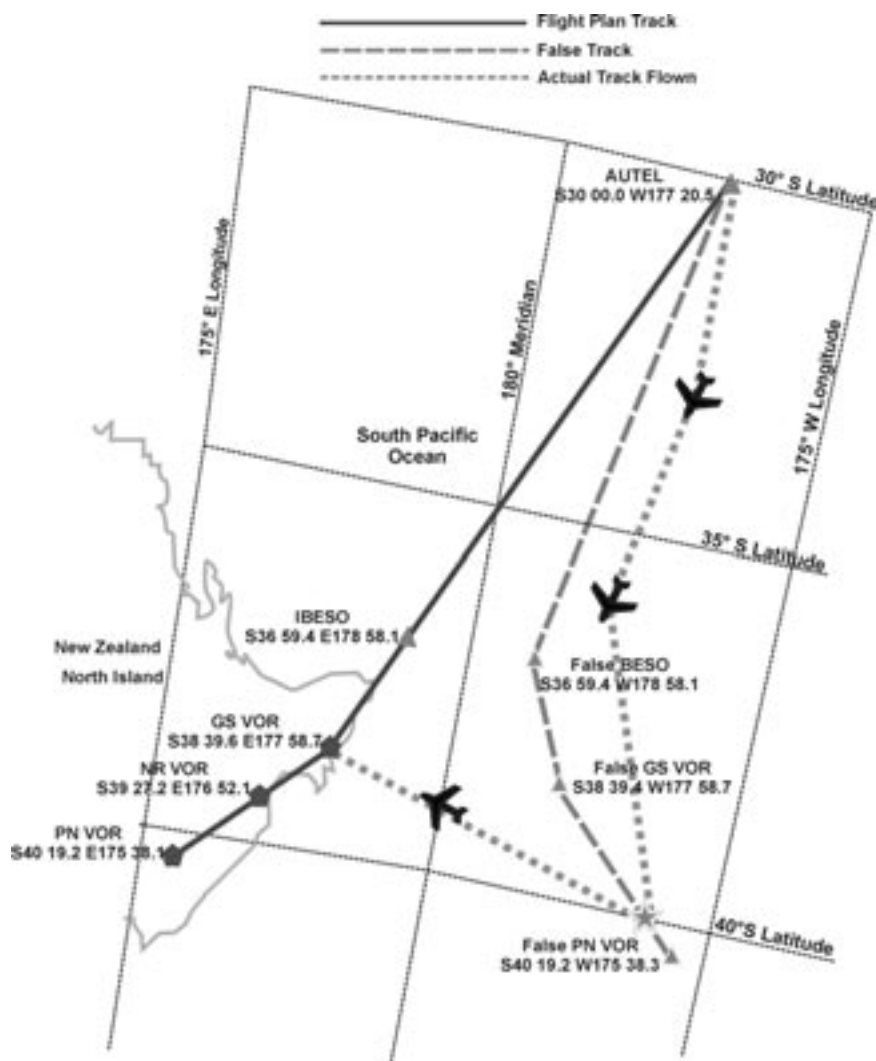
Flight plan track versus actual track flown

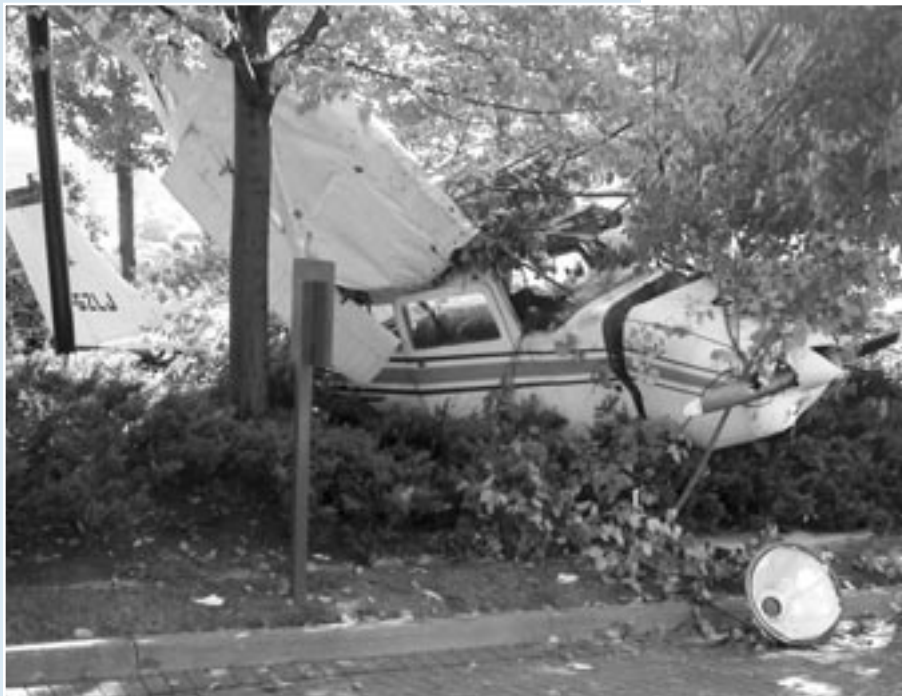
The aircraft was over a densely populated area, and the only suitable clearing was surrounded by trees and nearby buildings.

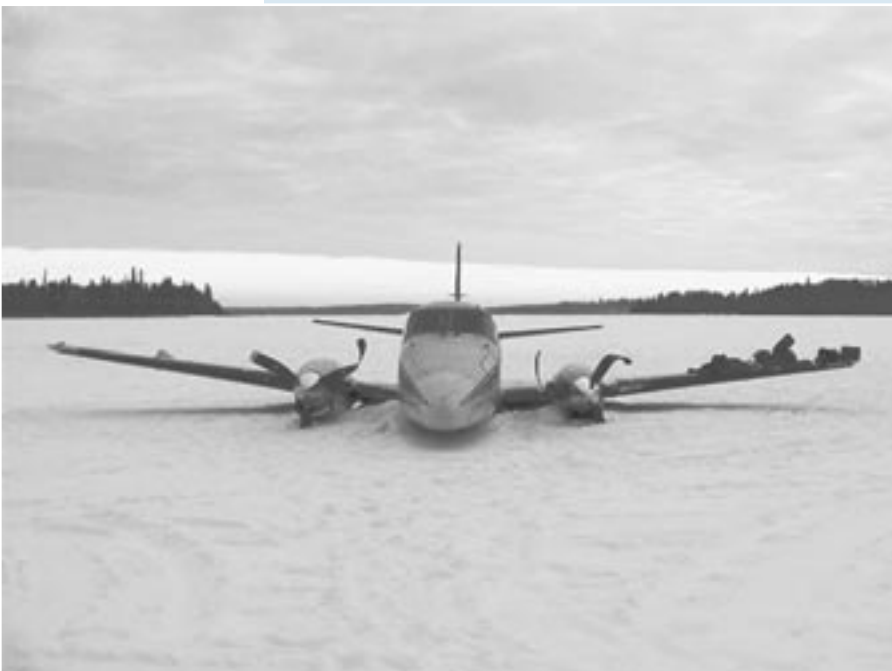
The Beech 99 after it struck the frozen surface of the lake

After the accident, Transport Canada met with company officials. They agreed to amend standard operating procedures to state that, after take-off, no turns will be performed below 1000 feet above ground level unless air traffic control so instructs. Transport Canada also completed a scheduled routine company conformance audit. The company was addressing issues arising from the audit.

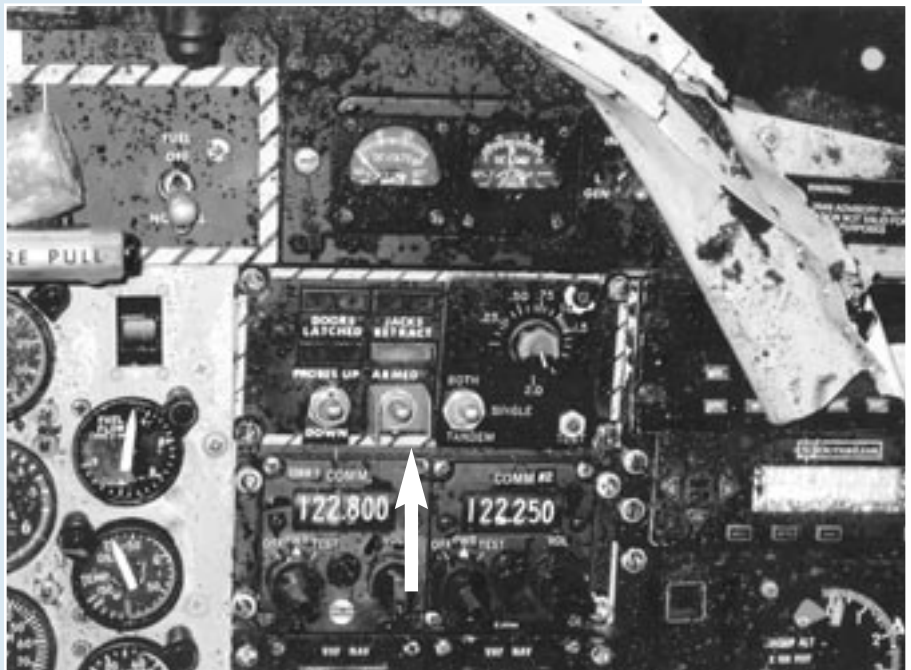
Prior to scooping, the bomb door armed switch on the centre panel must be selected OFF to prevent inadvertently activating the bomb door-open operation if the bomb door push button switch is pressed. The armed switch should be ON only after the scooping operation is complete, and the floats have cleared the water surface. The door armed switch was found ON after the occurrence.

System indicating lights and door armed switch (indicated by white arrow) in the ON position

During the approach, the Vital Action Checklist was not completed as per the standard operating procedures, and the bomb door switch was left in the ON position. After completing the scooping operation, the pilot intended to retract the probes by pressing the probe switch, but inadvertently pressed the adjacent bomb door switch. Since this system remained armed from the previous bombing run, the doors extended into the water. The drag from the doors and the water rushing into the floats through the door openings resulted in the aircraft nosing over. The proximity of the probe and bomb door switches, and a missing hinged cover plate on the bomb door switch increased the likelihood of selecting the bomb door switch instead of the probe switch. The cover plate had not been re-installed following maintenance.
